Longevity Test – RVS Company Car

Vehicle make: 1991 Oldsmobile
Model: Cierra Cruiser (ex-Canada Post car)
Engine: 2.5L, 4 cylinder
Mileage: 457,506km (retired in late 2008)
Purpose: To test the durability and effectiveness of RVS Technology

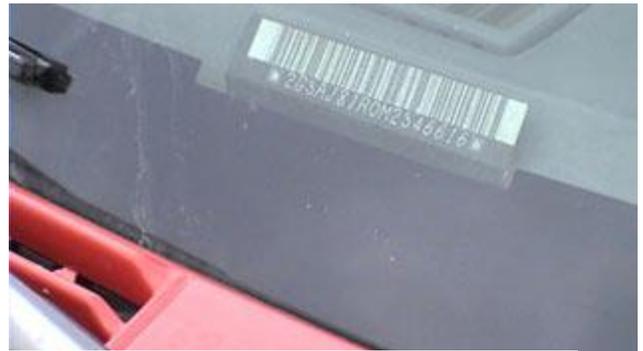
At 306 943km the engine's health did not seem very promising and a compression test was conducted. conducting the first compression test before the application of RVS. Compression in all four cylinders was very low, cyl. #3 being the lowest at 40psi:

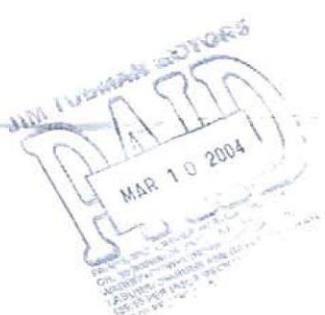
Further compression testing was conducted at the Jim Tubman GM dealer in Ottawa, Ontario, Canada. The mileage of the vehicle was now 314,873km, a full 7,930km after applying the first RVS treatment. The compression numbers were staggering. Compression in all cylinders was up to 140-150psi! You can see a copy of the compression test below:

PARTS/LABOUR DESCRIPTION	QTY./HOURS	PRICE	SALE
A COND: (459999) ENGINE COMPRESSION TEST. CAUSE: ALL CYLINDERS HAVE GOOD COMPRESSION. CORR: #1=150, #2=145, #3=150, #4=140. Tech:016Y - [C] P:0.00 L:89.95 O:0.00 Tx:13.50 T:103.45	1.00	89.95	89.95

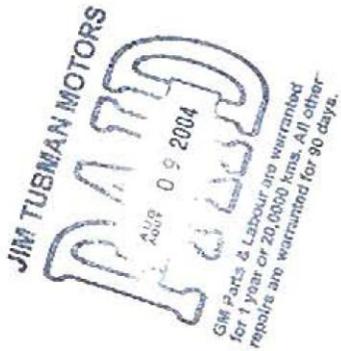
Update: Sept 02.2004*: A new compression test was conducted at Jim Tubman GM, and further improvement in the compression of all cylinders has been recorded. It appears that with 324,938km on the clock, 17,995km after the initial treatment, the engine is showing no signs of diminishing compression – quite the contrary, compression is slightly higher across the board. Here are the new figures:

Invoice # : WO- 205686 Invoice Date: 08/09/04 Page # : 1 Cust # : NADJ03 CUSTOMER COPY	
CHEVROLET - OLDSMOBILE - CHEVY TRUCKS 1770 Bank St. Ottawa, Ontario K1V 7Y6 Let's Talk about TRUST		Sales: 733-4050 - Fax: 733-9164 - Service: 733-1251 - Collision Centre: 733-0152 - Parts: 733-5483					
CUSTOMER NADJAKOVA, OLGA 2577 FOX HOLLOW CR GLOUCESTER, ON K1T 1X5 P.O.#		YEAR MAKE/MODEL 1991 OLDSMOBILE CIERA		COLOUR / /		IN SERVICE DATE / /	
		VIN. NO. 2G3AJ81ROM2346616		DATE IN 08/09/04		ODOMETER IN 324938	
		TIME PROMISED 08/09/04		GMPS/MRP WAITER		SERVICE ADVISOR 003	
		WORK TEL (613) 261-3232		HOME TEL (613) 733-8986		STOCK NO ATPL 708	
						HOURLY LABOUR RATE 89.95	
PARTS/LABOUR DESCRIPTION				QTY./HOURS		PRICE	
A COND: (459999) PERFORM ENGINE COMPRESSION TEST CAUSE: 150 PSI ON ALL 4 CYLINDERS Tech:060Y - [C] P:0.00 L:89.95 O:0.00 Tx:13.50 T:103.45				1.00		89.95

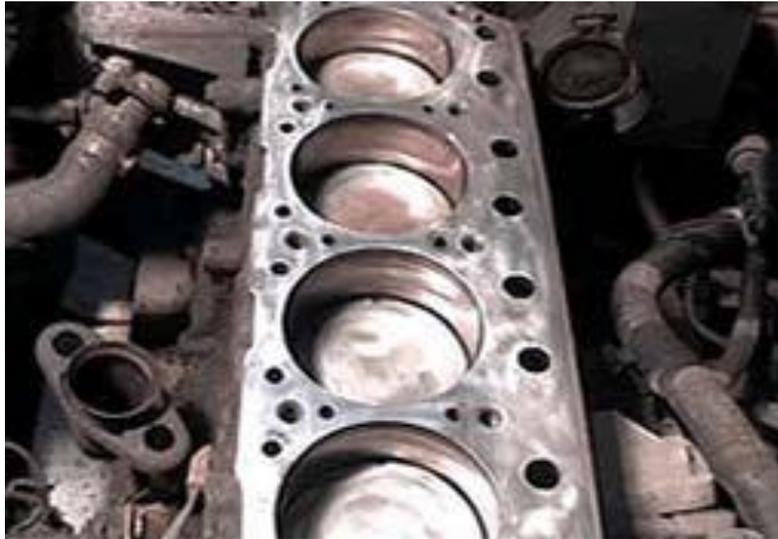
The car was driven on a daily basis, doing product deliveries throughout the Ottawa Region. The engine continued to operate smoothly and fuel efficiency appeared to be holding steady. At 314,710km the headgasket blew, and the vehicle was taken to Mob's Auto Service in Ottawa. The mechanics were so impressed by the look and feel of the cylinder walls, being perfectly smooth to the touch with no visible micro-scarring, that they took a short video of it. You can see a picture extracted from that video below:
